Integrity of the Interface Between Denture Base and Soft Liner: A Scanning Electron Microscopic Study

G. Muralidhar · C. L. Satish Babu ·
Shilpa Shetty

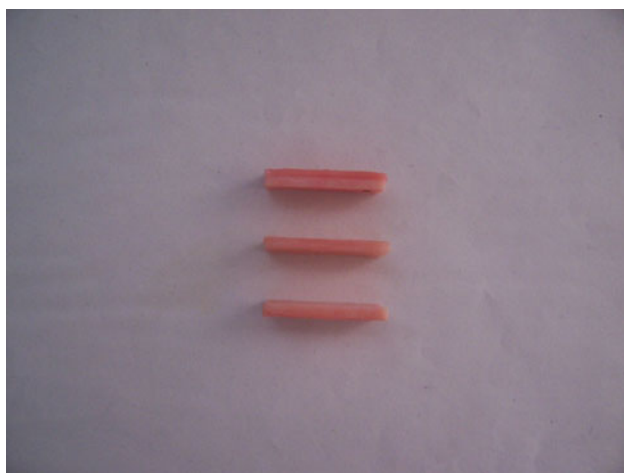
Fig. 1 Acrylic specimens with soft liner material bonded to them

The heat cured acrylic resin component of the specimens was again invested in dental flasks and control group specimens with 2 mm thickness of soft liner were fabricated using the stainless steel template 1. The templates were flaked along with the acrylic component of the specimens taking care to ensure that the templates did not stray away from the acrylic component of the specimens. The two halves of the flasks were separated and the stainless steel template was removed for creating mould space for the auto polymerizing silicone soft liner. The heat cured acrylic component of the specimen was coated with a primer using a hair brush both of which were supplied by the manufacturer. The soft liner was mixed in paper pad using equal amounts of catalyst and base pastes according to the manufacturer's instructions. Thus, mixed soft liner was applied to the primer treated heat cured acrylic component of the specimen and was processed using compression molding technique. Similarly group A, group B and group C experimental specimens were prepared using stainless steel templates 1, 2 and 3 respectively. Thus, prepared specimens were finished using a special type of rotary instrument supplied by the manufacturer (Fig. 1).

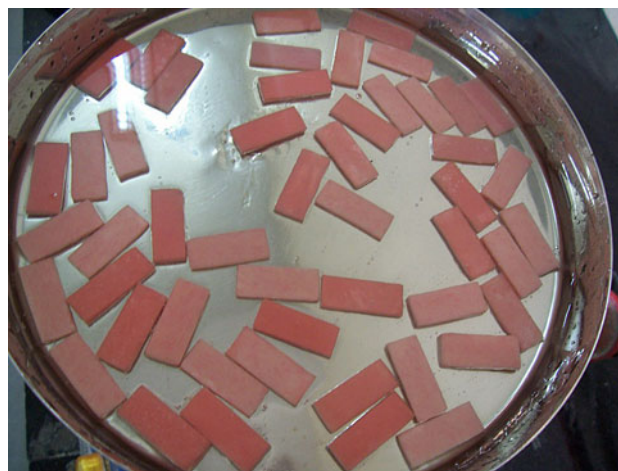
Fig. 2 Experimental specimens immersed in artificial saliva

All the experimental specimens were then aged for three months in a thermostatically controlled artificial salivary bath which maintained temperature in the range of $37 \pm 4^\circ\text{C}$. The specimens were alternatively soaked completely in artificial saliva and water for about 16 h and 8 h respectively for a period of 3 months to simulate clinical conditions of wearing the removable prosthesis for 16 h a

day and keeping the prosthesis in water for 8 h to provide rest to the oral mucosal tissues (Fig. 2).

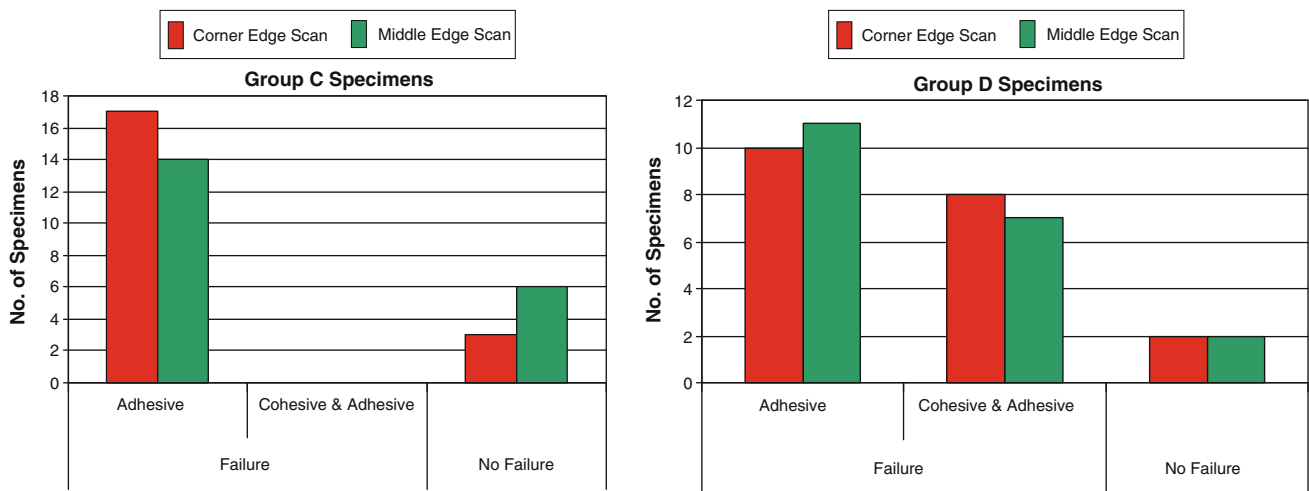
Graph 2 Graphical representation of types of failures observed in Group C and D specimens

Two scans were obtained for each of the specimens to study the integrity of the interface between the denture base and the soft liner, one each at the corner edge and the middle edge of the specimen at 20 kV and using a standard magnification of $100 \mu\text{m}$ in a scanning electron microscope (Graphs 1, 2).
