# To Evaluate the Effect of Various Surface Treatments on the Shear Bond Strength of Three Different Intraoral Ceramic Repair Systems: An In Vitro Study

Sidharth Jain · Hari Parkash · Sharad Gupta · Akshaya Bhargava

Received: 7 November 2011 / Accepted: 6 March 2013 / Published online: 14 March 2013  
© Indian Prosthetic Society 2013

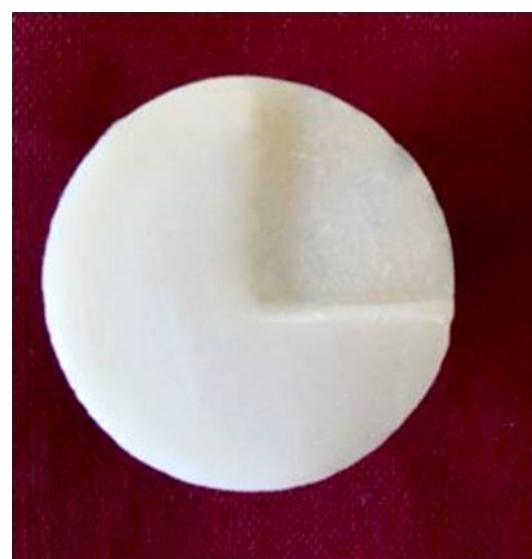
**Fig. 1** Defect formation (Group I,  $n = 60$ )

The one hundred and twenty metal-ceramic discs were divided into ceramic substrate (Group I,  $n = 60$ ) & metal substrate (Group II,  $n = 60$ , according to the defect location. The defect in the Group I ( $n = 60$ ) discs were created to exposed body ceramic by making depth orientation grooves. These depth orientation grooves were reduced to achieve a uniform thickness of 1.2 mm (Fig. 1) with the help of straight diamond fissure bur of 2 mm diameter (ISO shape 152, Bestell-Nr, Order-No. 531535C, DFS, Landenstrabe, Riedenburg). The defect in the Group II ( $n = 60$ ) discs were created until metal was exposed in 1/4th of the total area of the sample (Fig. 2).

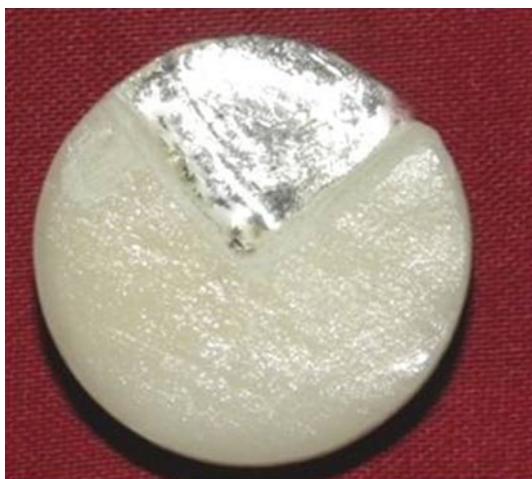
**Fig. 2** Defect formation (Group II,  $n = 60$ )
