Clinical Report

Unconventional prosthodontics: Post, core and crown technique

Murali Srinivasan

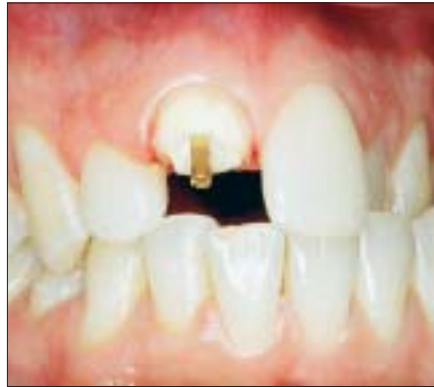
Figure 4: Prefabricated gold-plated post-cemented with zinc phosphate luting cement

4. A triple shoulder axial preparation was adopted in this case with the already existing shoulder accounted as the first shoulder, and further subsequent shoulders were meticulously prepared in the radial axial regions of the tooth to receive the composite resin core. After optimal preparation of the canal length and the shoulders, the appropriate post for the prepared length and diameter was tried into the canal and cemented using zinc phosphate cement [Figure 4].

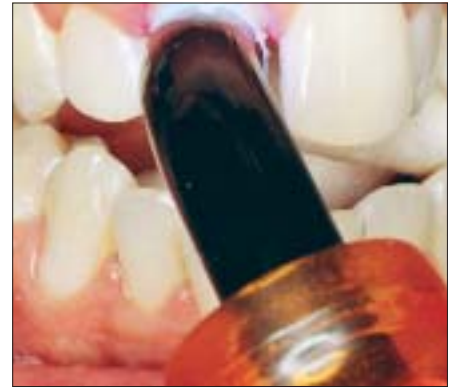
Figure 7: Curing being completed

- 6.7. After the initial light cure, utmost care was exercised and the porcelain crown was then gently teased out from the initially cured core [Figure 6]. The molded core was inspected for any defects and then completely light cured until final set [Figure 7]. After the final polymerization of the constructed core, re-preparation was done to ensure proper fit and eliminate any prematurities between the core and the crown [Figure 8].

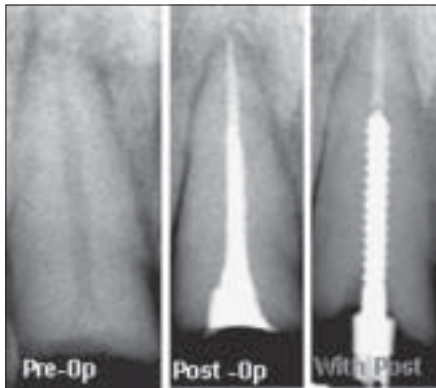
Figure 2: Preop and postop radiographs

1. Single sitting root canal therapy was performed abiding with the sound principles of endodontic therapies. Root canal preparation was performed using a rotary Nickel-Titanium (Ni-Ti) file system (ProTaper[®], Dentsply) and obturation was completed with Pro-taper gutta-percha using the single cone obturation technique, the entrance cavity was temporarily sealed with a temporary cement; a gross scaling procedure was performed to eliminate the presence of any supra/sub gingival plaque and calculi deposits present on the fractured tooth. The patient was recalled after 24 h for follow-up and further management [Figure 2].

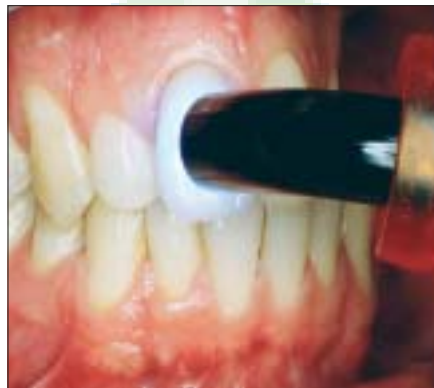
Figure 5: Crown packed with core build-up material and initial curing of core build-up material being carried out

- 6.6. The ceramic crown was then approximated onto the tooth and held in place tightly to expel any excess material flow. The excess material was carefully removed using an explorer and the margins of the crown was light cured for 6-8 s to facilitate initial core hardening [Figure 5].

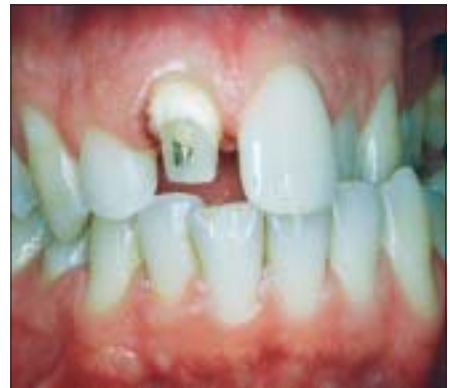
Figure 8: Completed final core

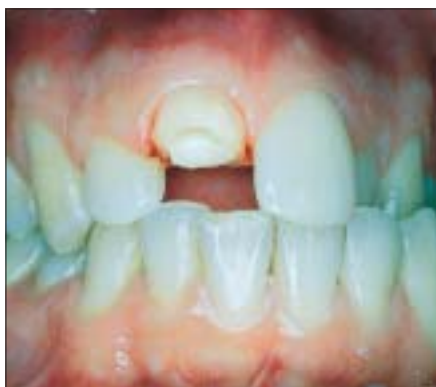
Figure 3: Root canal filling excavated and canal prepared for post-cementation

2. After 24 h, the entrance filling was removed and the canal optimally re-prepared up to the apical two-thirds to receive the prefabricated gold-plated post (Svenska Dentorama gold-plated prefabricated post) of appropriate diameter [Figure 3].

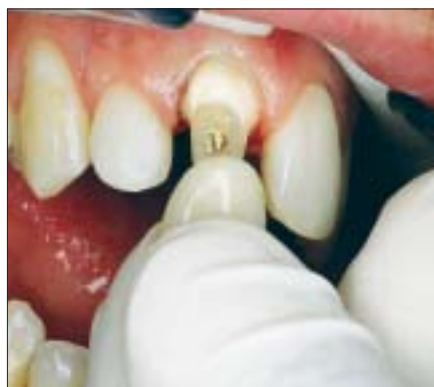
Figure 6: Crown being gently removed from the initially polymerized core

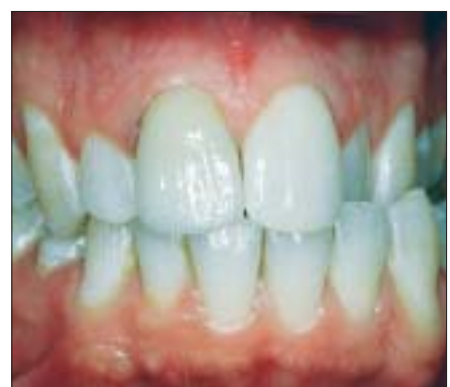
Figure 9: After final cementation of the crown

1. The ceramic crown was cleansed to eliminate the vaseline from the inner surface, and the inner surface was sandblasted using a chair-side mini-blaster. The completed core was then polished using polishing paste and composite polishing brush to eliminate any vaseline residue from the surface.
2. The crown was again try-fitted to check the marginal integrity, fit and occlusal relations. After the necessary corrections were made, the crown was finally cemented using a zinc phosphate luting cement [Figure 9].
