Original Article

Evaluation of the failure modes and load-bearing capacity of different surface-treated polyether ether ketone copings veneered with lithium di-silicate compared to polyether ether ketone copings veneered with composite: An *in vitro* study

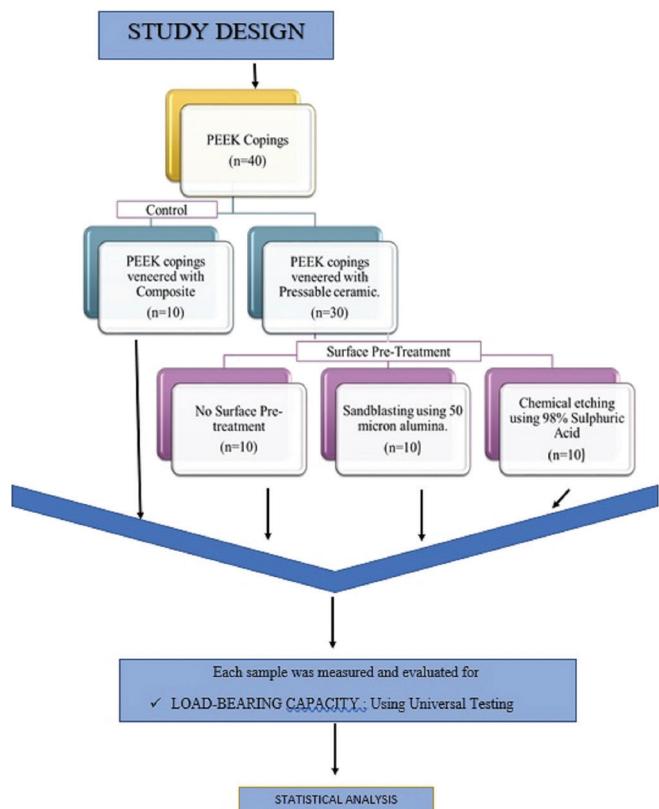
Figure 1: Study design, division of specimens according to different surface pretreatments, veneering composite resin, and lithium disilicate veneering

The PEEK FDPs were fabricated using rapid prototyping techniques (subtractive). This was followed by veneering with UDMA-based composite in case of 10 PEEK copings and lithium disilicate veneering on differently surface-treated 30 PEEK copings. To avoid confounding variables, the same milling machine was used for fabrication of all 40 PEEK FDP copings. The study design is shown in Figure 1.

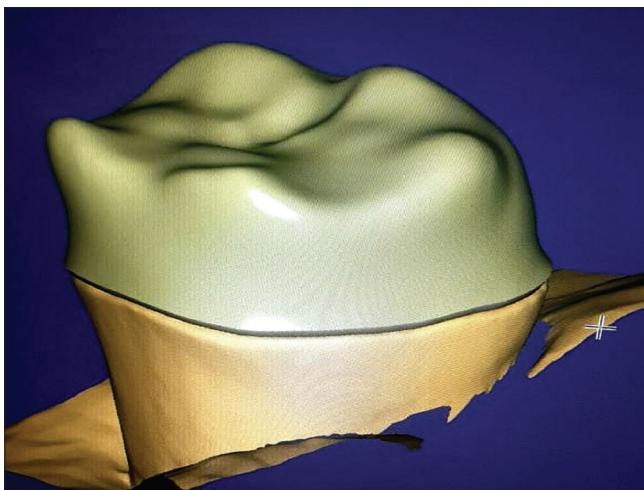
Figure 2: Computer-aided design designing of polyether ether ketone coping

The prepared typodont model was scanned using the Identica Hybrid Scanner, MEDIT. The scanning was done using 3-axis impression scanning technique to prepare the computerized die. The scanned data were thereafter sent to the DentalCam 7 software (VHF, Germany) [Figure 2]. This CAD data were used to design the required PEEK coping of 0.5 mm thickness. On the basis of the master design, the milling process was undertaken. The 4-axis milling process was carried out using the K4 milling machine (VHF, Germany). 40 standardized PEEK copings were milled using dry machining/milling. The PEEK dental disks (BIO-HPP, Bredent, Germany) with A2 shade were used.

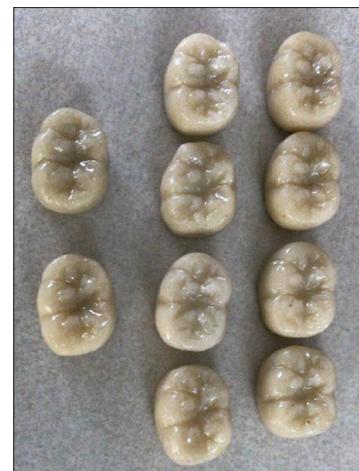
Figure 3: Composite veneered polyether ether ketone fixed dental prosthesis

model, a silicone index (Zetaplus, Zhermack, Italy) was created, enabling for a consistent and repeatable anatomic form fabrication. After utilizing the incremental method to apply the veneering composite resin on the PEEK coping, excess material was eliminated when the silicone mold was overlaid. The occlusal height of the composite was around 1–1.5 mm. Layering was followed by light polymerization for 180 s with bre.Lux power unit 2 (Bredent, Germany). The power unit makes use of full-range LED light with an in-built temperature control system. All the 10 samples of composite veneered PEEK were finished and polished and were stored in a dry environment [Figure 3].

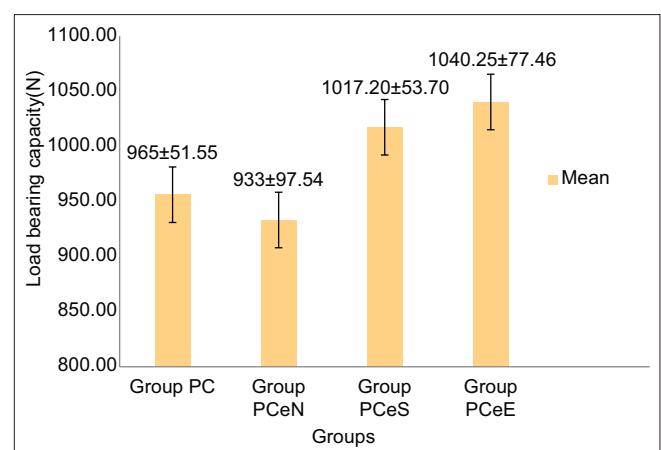
Graph 1: Bar-chart presentation of the results of the load-bearing tests (mean values and standard deviations) of different groups

The data were collected in Newton (N) for load-bearing capacity. Descriptive statistics (mean, standard deviation,) were computed for each group [Graph 1]. A one-way ANOVA analysis was used to test for significant differences between the groups, followed by a Bonferroni *post hoc* test (preset = 0.05). Statistical Package for the Social Sciences was used to do a *post hoc* power analysis (SPSS Inc. Chicago, IL, USA version 26). The level of significance was set at 5% ($P < 0.05$).

Groups	Minimum	Maximum	Mean	SE	SD
Group PC	856.50	1024.50	956.05	16.30	51.56
Group PCeN	786.60	1042.50	928.71	28.96	91.57
Group PCeS	942.50	1108.50	1017.20	16.98	53.71
Group PCeE	905.50	1188.00	1040.25	24.50	77.47

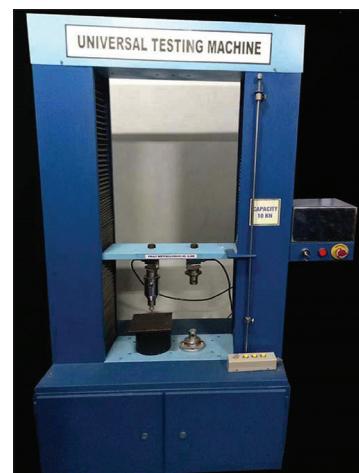
Figure 4: Universal testing machine used to measure load-bearing capacity for polyether ether ketone fixed dental prosthesis

Each PEEK veneered FDP was placed over the metal die and was loaded till a crack occurs. This was done using a Universal Testing Machine (model No: UNITEST-10, ACME) [Figure 4] which was attached to a connecting laptop, which had an in-built software (ACME, INDIA). The crosshead speed was 1 mm/min. A metal plunger with a diameter of 5 mm was then used to load the force into the central fossa of the occlusal surface of the crown. The amount of force was steadily increased from zero to a point where it abruptly decreased by more than 20 N. This sharp drop suggested that the sample had fractured. The force of fracture was calculated from the highest force up to the point of rapid decline. The location of cracks and fragmentation of core and/or veneering materials were also analyzed during the visual examination. The failures are of three types: cohesive

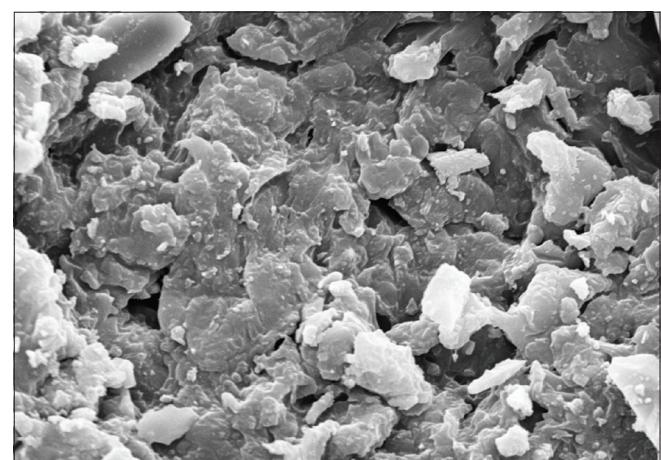
Figure 5: Surface topography: Untreated polyether ether ketone surface ($\times 5000$)

External surface of PEEK coping underwent pretreatments using 50 μ alumina and 98% sulfuric acid before luting it with lithium di-silicate Shell. The untreated PEEK surface [Figure 5] was kept as a control surface to analyze the characteristics after pretreatments. Distinct surface modifications were visible under an electron microscope with both the pretreatments. On PEEK's external surface, sandblasting with a particle size of 50 μ alumina resulted in an irregular surface that was more jagged in comparison to untreated PEEK coping. Chemical etching with 98% sulfuric acid resulted in a complex fiber network with a porous surface. At higher magnification, the H_2SO_4 resulted in a blister and porous surface [Figure 6]. This zone is accepted to form apparent tag formation with resin material.

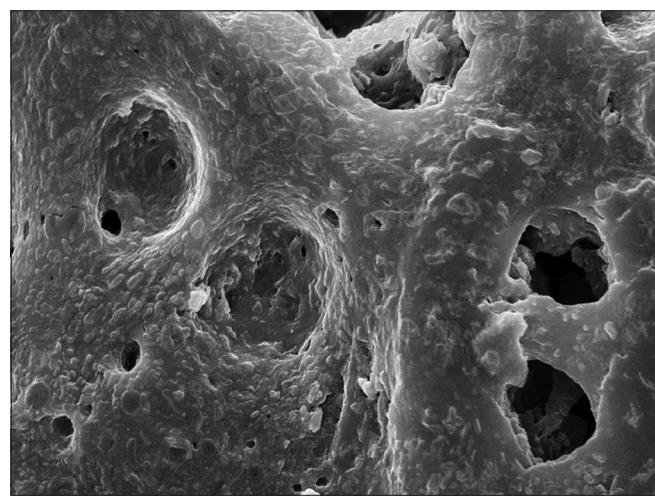
Figure 6: Surface topography: Etched with 98% sulfuric acid (x5000)

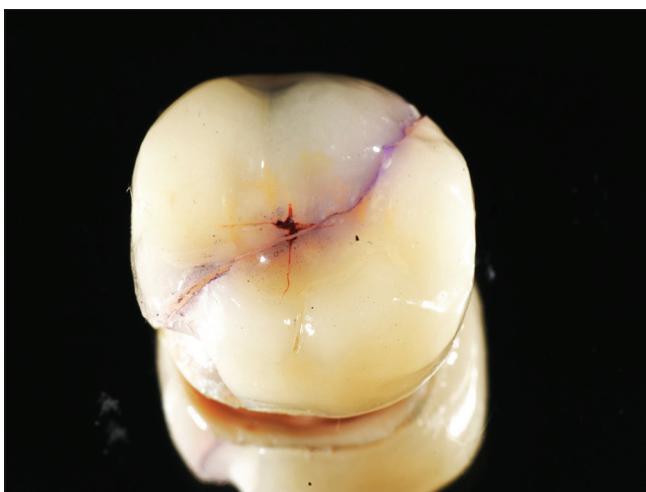
Figure 7: After fracture load measurements. Adhesive failures between polyether ether ketone framework and veneering lithium di-silicate

- All the samples in PEEK FDPs in Group PC suffered adhesive failures pertaining to marginal ridge area [Figure 7]
- Composite chipping was seen in three composite veneered PEEK FDP's out of ten, with detachment of veneering material
- In lithium di-silicate veneered PEEK FDPs, all the samples suffered adhesive failures with detachment

In case of lithium di-silicate veneered FDPs, an interesting fact has been observed that after the fracture of veneering material, the remaining lithium di-silicate gets debonded from the PEEK substructure. This finding was mostly seen in Group PCeN. In this group, no etching or surface treatment of PEEK coping was done, resulting in low bonding between PEEK and lithium di-silicate shell. Therefore, they too had devastating adhesive failures. The location of fracture in lithium di-silicate veneered PEEK is mostly along the central fossa of mandibular first molar.

The highest loads are concentrated in the central fossa resulting in shear stresses along the lateral surface of PEEK substructure. These shear stresses cause debonding of lithium di-silicate and fracture of veneering material.
